RELIABILITY ASSESSMENT OF OVERHEAD TRANSMISSION LINE TOWERS IN THE REPUBLIC OF CROATIA

Ana Komorski, Davor Skejić, Darko Dujmović

Original scientific paper

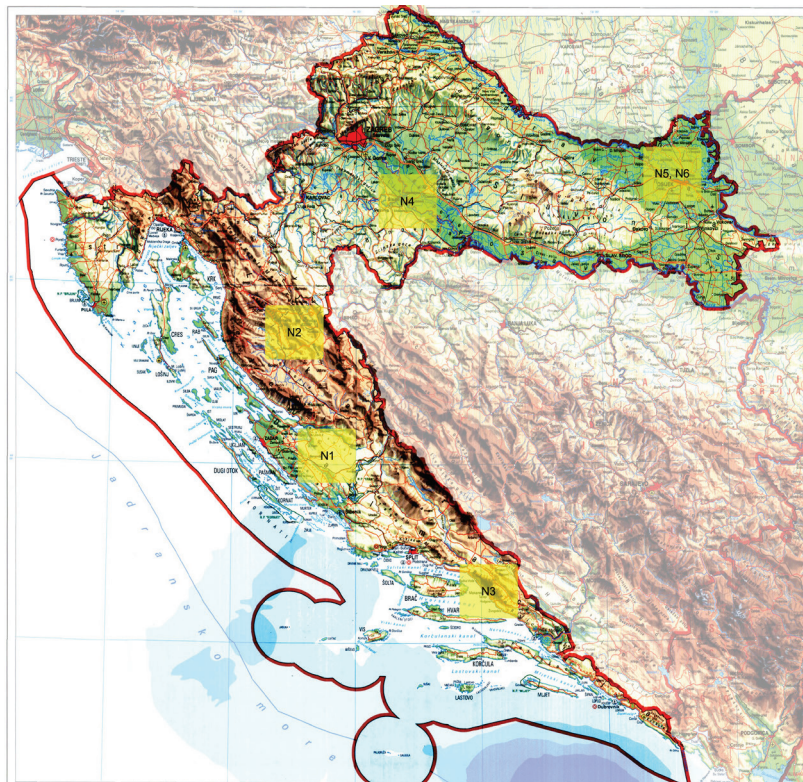
Figure 2 Map of Croatia with locations of the analysed representative towers

Certain regions of Croatia in which the damages of the overhead transmission lines have happened can be seen in Fig. 1. The following towers were chosen for the analysis: tower N1 was damaged by wind load, tower N2 was damaged by ice load, tower N3 was damaged by the combined ice and wind load and towers N4, N5, N6 that are still undamaged. Towers N1, N2, N3 and N4 are 110 kV standard voltage towers and towers N5 and N6 are 400 kV standard voltage towers. Locations of these towers are shown in Fig. 2.

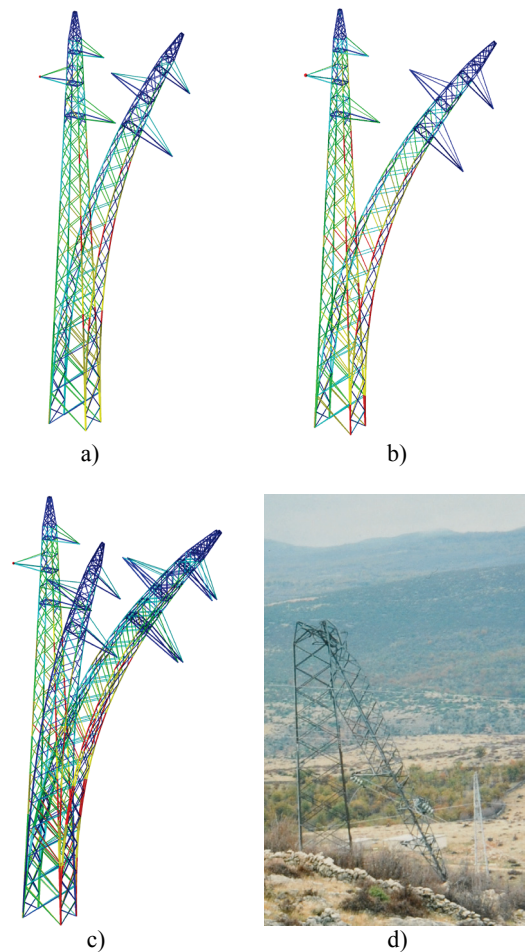
Figure 4 Graphical representation of the maximum element utilization level of the tower N1: a) Regulation [1], b) EN 50341-1 [2], c) EN 50341-3-4 [5], and d). Photo of 35 kV tower damaged due to wind load.

Fig. 4 shows graphical results of the analysis of the tower N1. According to the Regulation [1], the results on deformed structure for the governed load combination 68.1b are shown in Fig. 4a). Fig. 4b) shows the utilization level of the members designed according to the EN 50341-1 [2] and deformation is given for the governed load combination N1. Fig. 4c) presents the results according to the EN 50341-3-4 [5] and the deformations are shown for the governed load combinations A and B.

All deformations are 50 times magnified in relation to the geometry of the structure. Typical damage of the 35 kV tower due to wind load is shown in Fig. 4d).

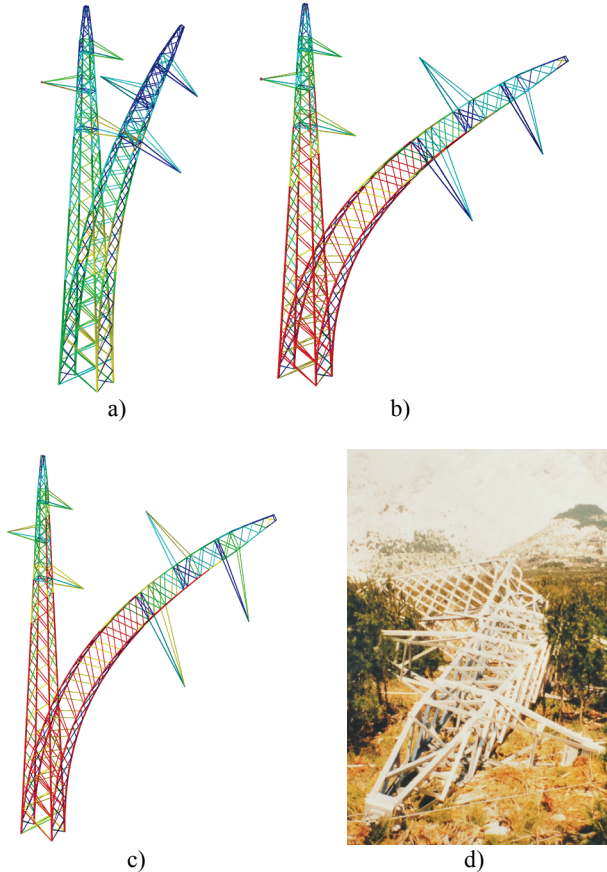
Figure 6 Graphical representation of the maximum element utilization level of the tower N3: a) Regulation [1], b) EN 50341-1 [2], c) EN 50341-3-4 [5] and d) Photo of the collapsed tower N3 damaged on OHTL 110 kV Kraljevac - Makarska in 1993.

Fig. 6 shows graphical results of the tower N3. According to the Regulation [1], the results on deformed structure for the governed load combination 68.1b are shown in Fig. 6a). Fig. 6b) shows the utilization level of elements designed according to EN 50341-1 [2], a deformation is given for the load combination N7. Fig. 6c) presents the result of design according to the EN 50341-3-4 [5] and deformation is shown for the governed load combination D. All deformations are 50 times magnified in relation to the geometry of the structure. Fig. 6d) shows one of the collapsed towers type N3 that was damaged on OHTL 110 kV Kraljevac – Makarska.

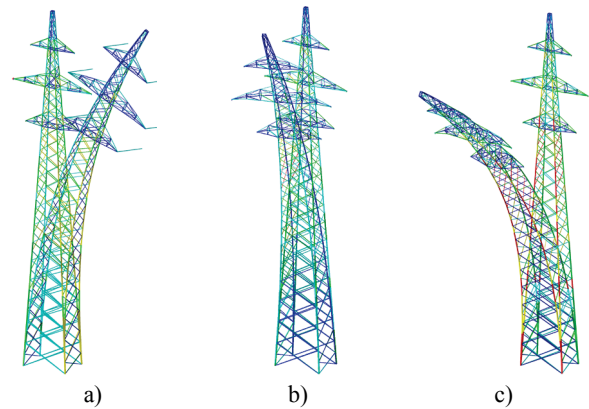
Figure 7 Graphical representation of the maximum element utilization level of the tower N4: a) Regulation [1], b) EN 50341-1 [2], c) EN 50341-3-4, [5]

Fig. 7 shows graphical results of the analysis of the tower N4. According to the Regulation [1], the results on deformed structure for the governed load combination

68.1b are shown in Fig. 7a). Fig. 7b) shows the elements utilization level designed according to EN 50341-1 [2] and deformation is given for the governed load combination 2c. Fig. 7c) presents the results of design according to EN 50341-3-4 [5] and deformation is shown for the governed load combination G_b. All deformations are 50 times magnified compared to the geometry of the structure.
