Efflorescence in a Conventional Wood Drying Kiln – A Case Study

In newly built conventional wood drying kilns white deposits often occur on concrete construction parts during the process. These deposits occasionally cause confusion with investors for the reason they do not know whether deposits originate from wood or concrete. In this paper, inorganic origin of such deposits in a specific wood drying kiln has been affirmed. And additionally, efflorescence is discussed.

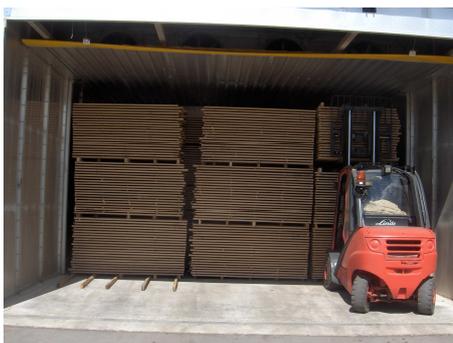
Figure 1. Conventional (aluminium/concrete) wood drying kiln interior (photo: Klarić)

Modern structures of conventional wood drying kilns mostly consist of reinforced concrete floor and parapet with superstructure of corrugated aluminium panels filled with insulated material such as water repellent mineral wool as a walls and ceiling (Figure 1). Construction of new conventional wood drying kilns is usually carried out in a way that the investor prepare a reinforced concrete base, while the kiln producer provides and assembles aluminium components and other necessary segments. However, in many cases the final outcome of drying kiln construction is not adequate (Figure 2), which results in incapability to properly conduct the drying procedure, and to achieve appropriate dry wood quality, thus inevitably leads to higher production costs and to dissatisfied investor (Chrisholm and Adams, 2000).

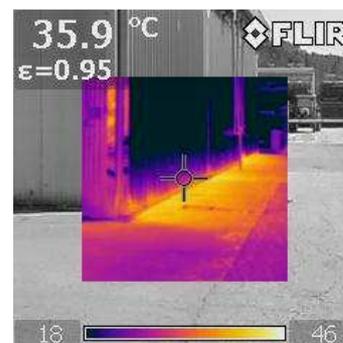
Figure 2. Infrared image of conventional wood drying kiln exterior, showing condensate and heat flow (photo: Klarić)

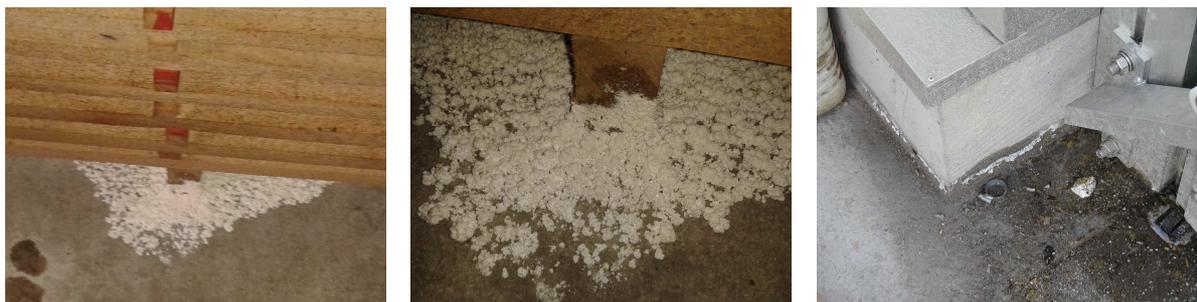
In a wood processing company in the Republic of Croatia new conventional wood drying kiln was built. Investor built reinforced concrete floor and parapet in advance according to technical specification of kiln manufacturer, before kiln assembly. After first procedure of wood drying white chunky deposits appeared on floor inside of a kiln and on the outside of the parapet (*Figure 3*). The first question that has come up in wood processing company was: What happened, and are those deposits originate from the wood or from the concrete?

Figure 3. Efflorescence; on wood drying kiln floor (left and middle), on the outside of reinforced concrete parapet (right) (photo: Pervan)

Immediately after on-site inspection it was clear that the deposits does not originate from the wood but from the concrete. Regardless of the stated conclusion, on investor request, the efflorescence samples were taken from the kiln and were subjected to the laboratory analysis. The primary objectives of this research investigation were (1) to exclude organic origin, and (2) to confirm inorganic origin of white deposits within wood drying kiln, respectively. The simpler analytical methods were used in order to fulfil the set objectives, through a microscopic examination; Mg^{++} and Ca^{++} presence, and phenolics absence determination.

To minimize efflorescence, additional care should be given during the construction of conventional wood drying kiln. Sand from a reliable source or washed sand should be used, and water with low content of solids and ions should be used, without exaggeration in free water content. Additionally, voids in mortar should be reduced to reduce capillary flow, by means of mechanical vibration. Most important, the transport of water through the structure towards the exposed surfaces should be hindered, whether by increasing the hydrophobicity with waterproofing admixtures and/or by lowering the permeability (Bensted, 2000). Concrete surface protective coatings are good solution, but which should be applied with regard to the conditions in which the structure is located, and according to strict manufacturer's instructions. Concrete structures within wood drying kilns are exposed to a broad range of chemical and physical reactions, as well as to different environments and influences. For instance, alternating wet and dry conditions, alternating hot and cold conditions, chemically aggressive environment, mechanical wear, exposure to freezing. All aforementioned influences should be taken into account when the wood drying kiln is being constructed.

4. The usage of concrete waterproofing admixtures and surface protective coatings is recommended to extend lifespan of the concrete floor.
5. Bad planning and small savings during drying kiln construction subsequently often cause difficulties in business like: dried wood defects, major repair expenses, employee stress, high energy consumption, *etc.*

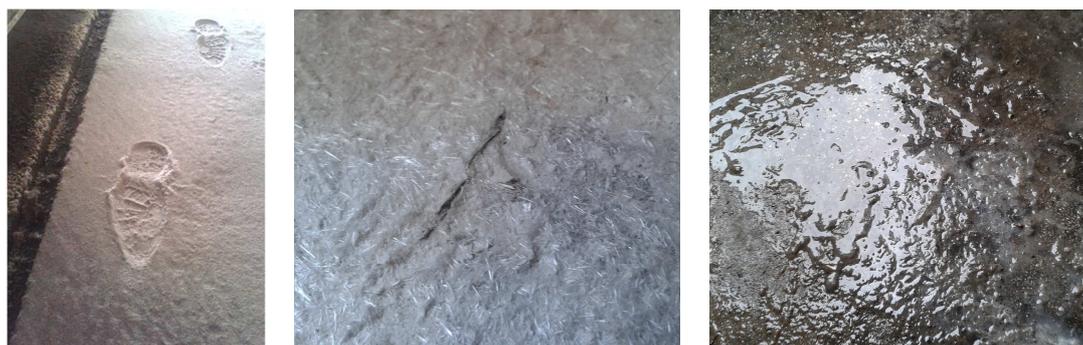
In generally efflorescence appears in a form of fine powdery deposits of water-soluble salts on masonry. But in conventional wood drying kilns, except in the form of fine powder (*Figure 9_{left}*, and *Figure 9_{middle}*), it can appear in a form of bigger chunks (*Figure 3*), because the evaporation of water is much greater, and the concrete is often rewetted (humidification, condensation, *etc.*) during wood drying process. Sometimes, during the process, while floor is wet efflorescence appears in a form of slimy and gooey mash (*Figure 9_{right}*).

Figure 9. Powdery deposits (left, middle); slimy and goeey mash (right) (photo: Pervan)

Efflorescence is considered to be only aesthetic problem in commonly masonry, however in wood drying kilns it could cause somewhat larger problems. When water-soluble salts are leached out, concrete becomes porous to some extent which enables additional moisture to enter and then concrete becomes susceptible to further degradation. Additionally, within the kiln, due to the drying of wood, different kinds of natural volatile compounds are emitted from the wood into the surrounding air, which are contained in water vapour and condensate as well (Pervan *et al.*, 2008). So this, mostly acidic moisture additionally damages concrete when it penetrates into the newly formed pores. In winter times, moisture contained in concrete pores is susceptible to freezing, and thus concrete micro cracks can occur. Such a surface weakened concrete floor is furthermore being damaged due to forklift movement and timber manipulation. Efflorescence appearance, however, cannot be 100 % prevented, but certainly can be minimized (Merrigan, 2000). During construction, sources of water-soluble salts should be minimized if possible. Water soluble salts can be present in any of the concrete components, such as cement, sand, water, or the soli under the kiln can be contaminated, and additionally water-soluble salts can be present in water which passes through concrete (if watertight insulation is not adequate). Regarding the water as a source of water-soluble salts, content of dissolved solids in the natural waters varies from place to place, as can be seen in *Table 4* for Croatia (mainly coastal belt).
